RE: Reserve Fund Study Update Report

RESERVE FUND ANALYSIS

TALL TREES

PREPARED FOR:
TALL TREES HOMEOWNERS' ASSOCIATION

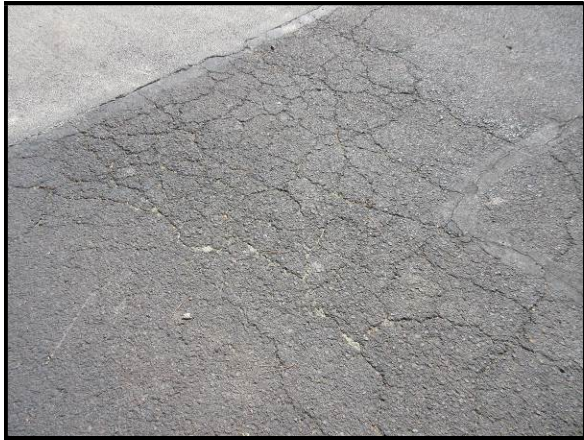
We noted much alligator cracking and long spider cracks in the asphalt of the tennis court parking area. The asphalt has reached the end of its useful life. The overflow parking areas along Oak Hill Drive appear newer and we did not note anything that would indicate premature failure.

Alligator cracking at tennis court parking area

The estimated life expectancy of parking lots is 20 to 25 years. With this in mind, we estimate repaving the overflow parking areas within the next eighteen years, while replacement of the tennis court parking area within the next year.

Costs for repaving the roads include milling of the asphalt surface in the amount of 2" and applying at minimum 2" of asphalt wearing surface course. Some full depth replacement may be needed on areas with rutting.

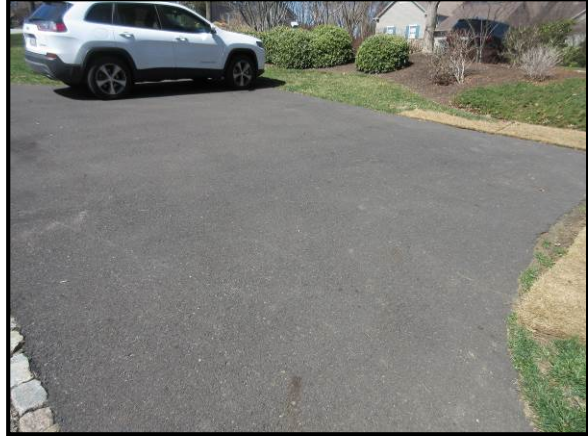
Overflow parking along Oak Hill Drive

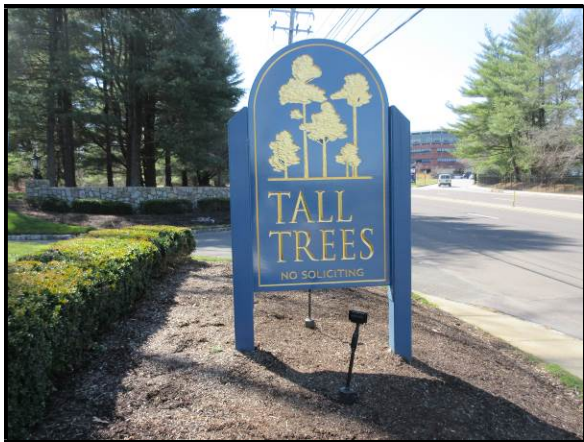
At the entrance to the community is an identification sign and wall features. The community identification sign consists of a composite sign mounted on two wooden posts. The sign is in good condition and reportedly was replaced in the last few years. We have scheduled for the eventual replacement in year fourteen (2035).

Community identification sign at entrance

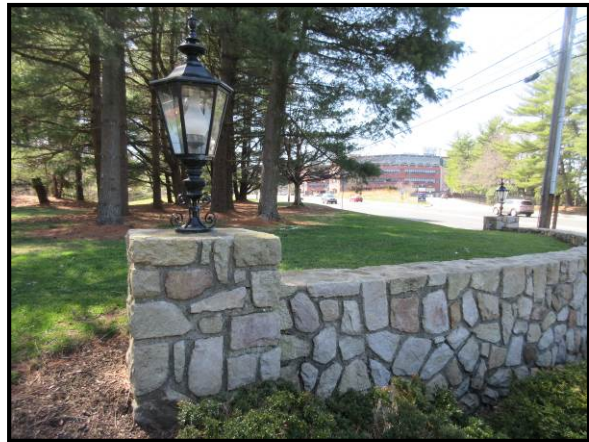
In addition to the sign, there are two stone veneer walls with pillars containing lanterns. We noted some cracking and deterioration of the mortar joints on the masonry wall. In the Reserve Fund Analysis, we include replacement costs for the lanterns but not the masonry wall. Pointing, if needed should be paid for under the operation and maintenance accounts.

Lantern and wall at entrance

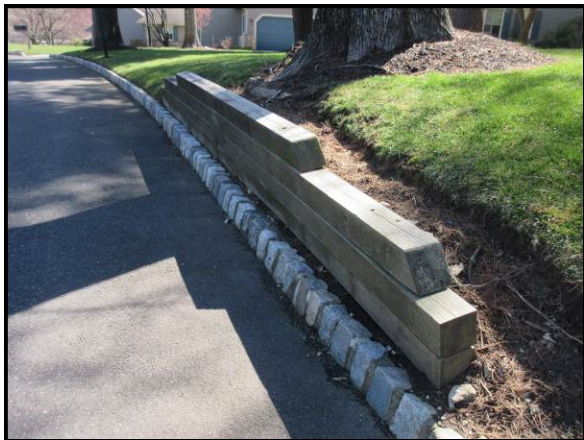
We did, however, include replacement of the wooden tie walls as they are both leaning severely. Eventually, replacement will be needed for both. We have included the cost to replace with a landscape block style wall, which has a longer useful life.

Wood tie wall at entrance to community

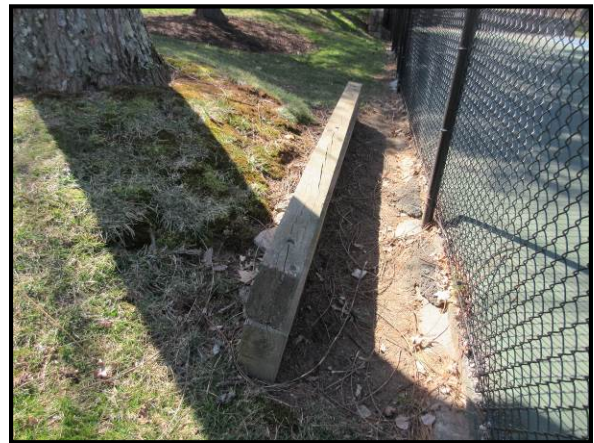
Wood tie wall near tennis court

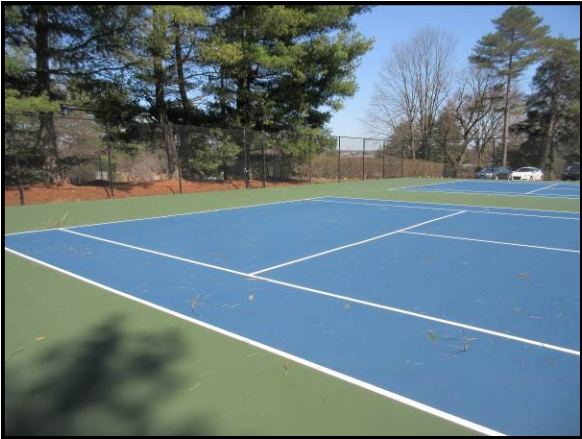
View of tennis court surface

In the Reserve Fund Analysis, we continue to include costs for the resurfacing and eventual replacement of the surface. Typically, resurfacing of the courts occurs on an eight-year cycle but this can vary depending on usage and weather conditions. Complete replacement should not be needed for 25 to 30 years. Items such as nets and posts are not included in the reserve fund account and should be paid for from the operating budget.

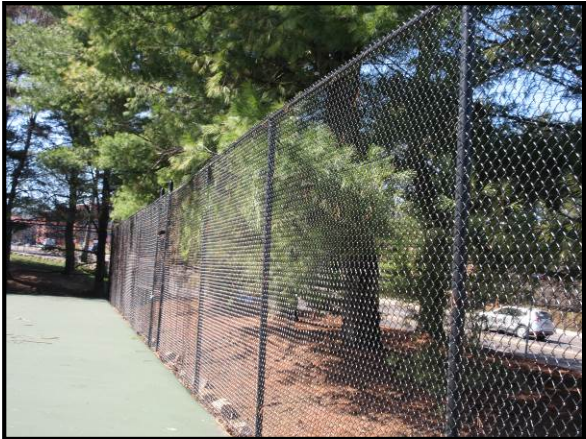
View of chainlink fence at tennis courts

We have assigned a useful life of 25 years for the chain link fencing surrounding the court structure with anticipated replacement occurring in year twenty-five, as this was recently replaced. To help extend the life of the fence, we suggest the trees overlapping the fence be trimmed back and no vegetation allowed to grow into the fence.

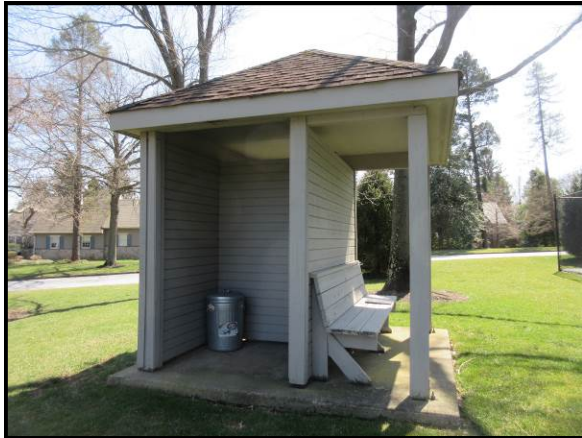
View of shed at tennis court

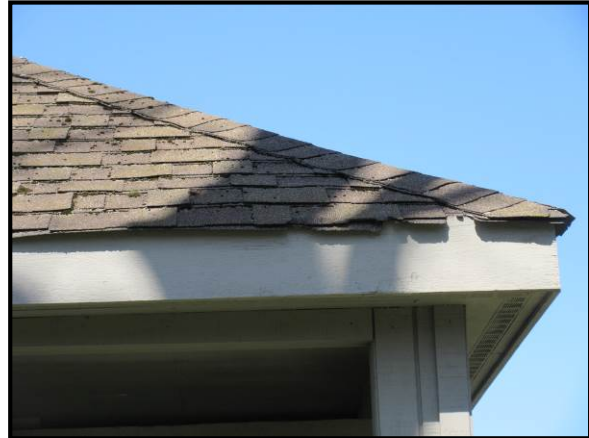
We noted that some of the shingles are starting to break and the one side of the roof has moss growing on it. We suggest that the tree overhanging the shed be cut back to prevent further wear and tear on the shingles. We have scheduled the upgrades to the shed in year five (2026).

Shed roof with moss & brittle shingles
