RE: Reserve Fund Study Update Report

RESERVE FUND ANALYSIS

TALL TREES

PREPARED FOR:
TALL TREES HOMEOWNERS' ASSOCIATION

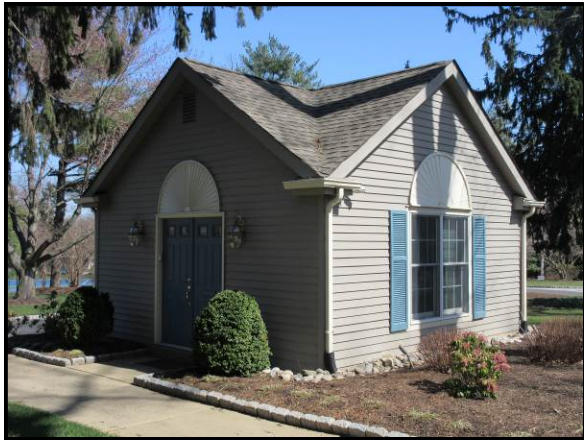
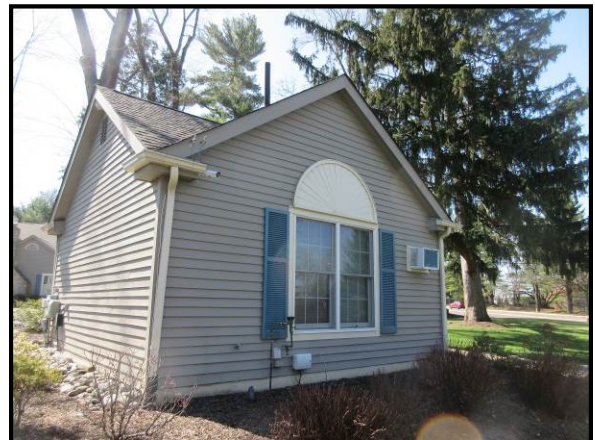
The Association recently renovated portions of the building including upgrading the bathroom fixtures, repairing water damage at the foundation on the southern elevation, installation of drainage on the exterior of the building, repainting, and replacement of carpeting.

On the island, at the entrance to the community, is a manager's office space. The building is a one-story structure which houses a storage closet, office space and bathroom. We included replacement costs for the roofing, including gutters and downspouts, front door, wall mounted exterior lighting, carpeting, security system upgrades, and an interior refurbish fund.

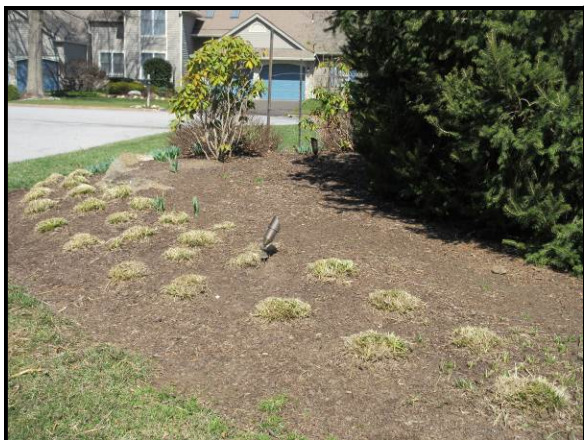
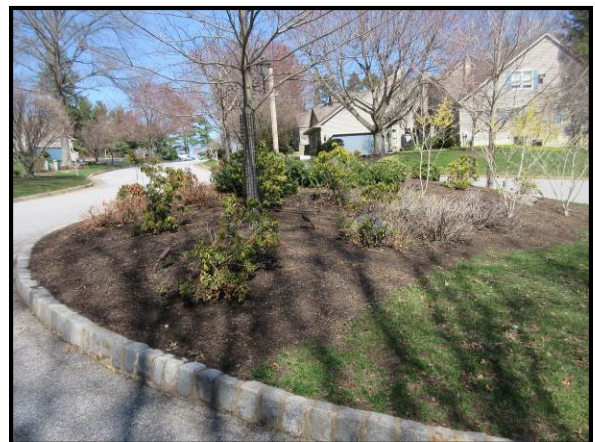
We continue to include a landscaping allowance in the reserve fund study. The allowance is \$5,000 to be spent every three years. Recently, the Association used these moneys on the islands located along the roadways. Also included for replacement in the study is the uplighting for the trees on the landscaped islands. We estimate the useful life of the lights to be 15 years.
